## Safety & Inspection

Defects in Pipelines and their Assessment

### Defects in Pipelines and their Assessment

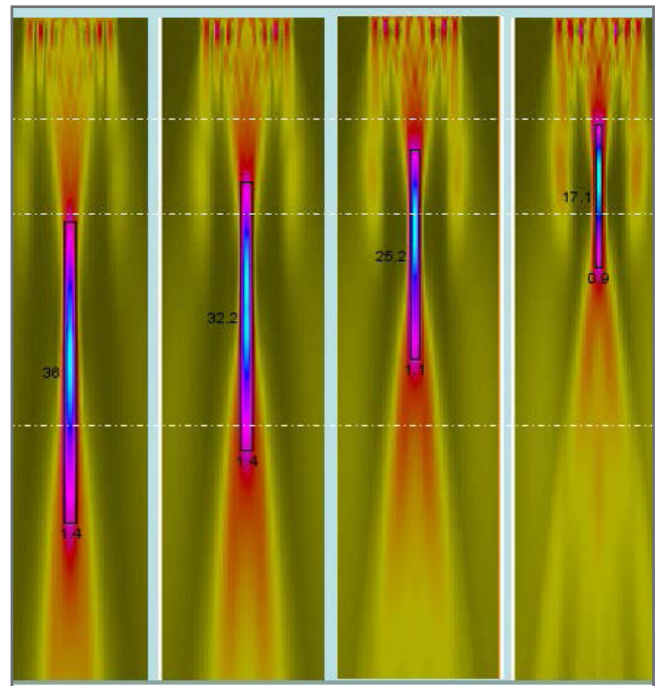
Figure 3 : Electronic focusing

With this kind of UT probe multiple features can be used to steer, focus, and scan beams with a single transducer assembly. Beam steering can be used for mapping components at appropriate angles (Figure 2). This can greatly simplify the inspection of components and defects with complex geometry. Electronic focusing enables optimisation of the beam shape and size at the expected defect location, as well as further optimisation of probability of detection. The capability of focusing on multiple depths also improves sizing of critical defects for volumetric inspections (Figure 3).

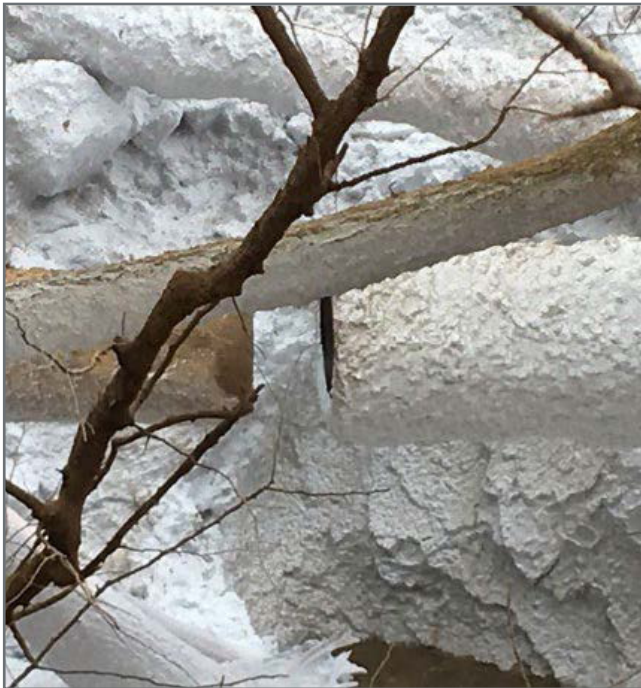
Figure 6: circumferential fatigue crack in a CO2 transport pipeline due to ground movements [6]

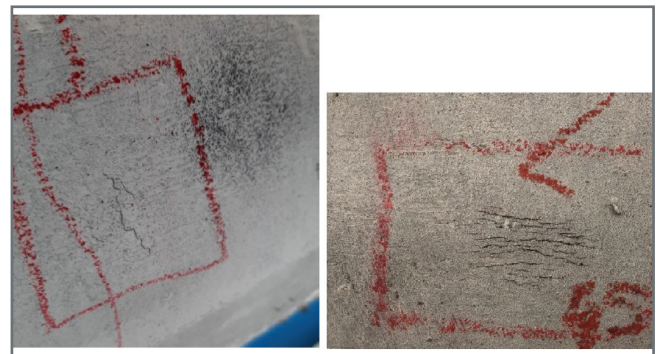
Figure 7: Circumferential and axial crack field SCC from TRAPIL field investigation

SCC can be axial or circumferential, when considering stresses described earlier.

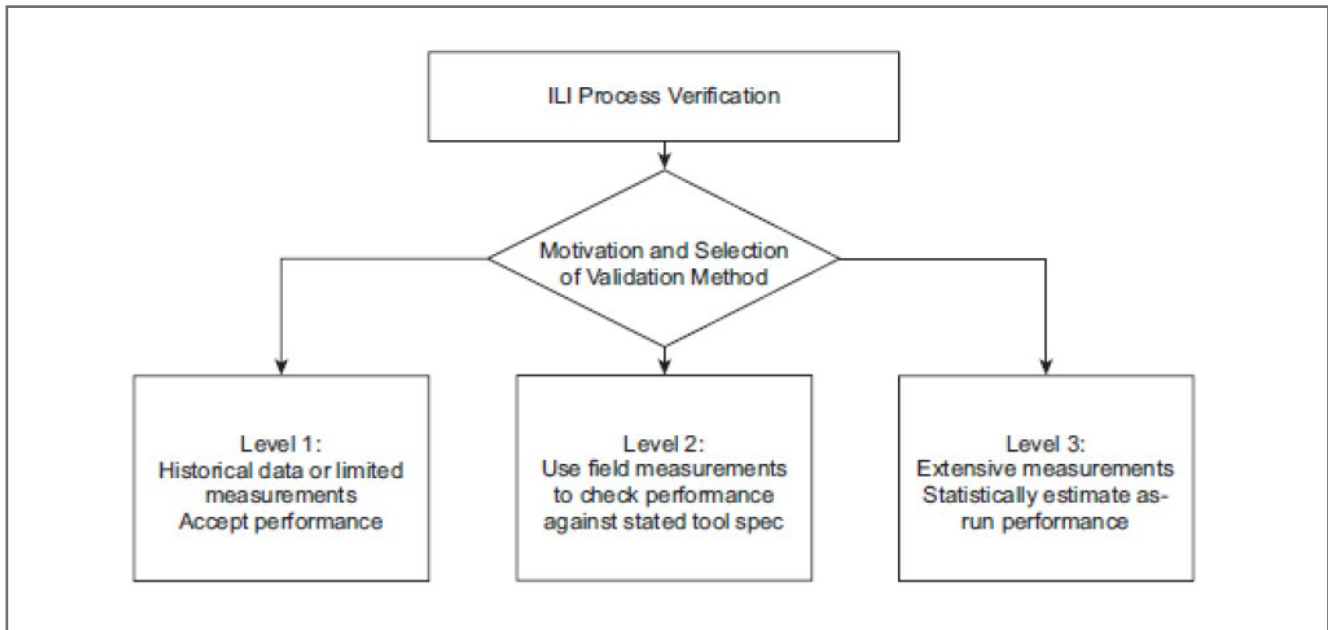
Figure 9: Overview of Three Levels of ILI Validation from API-1163 [3]

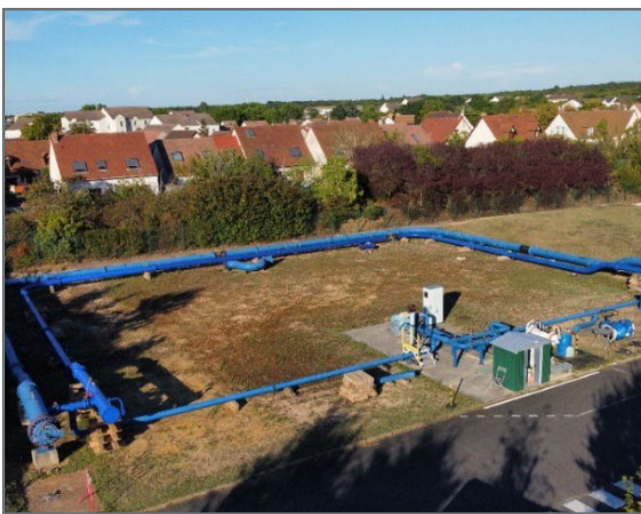
Figure 10: Trapil's 12 and 20" test spools

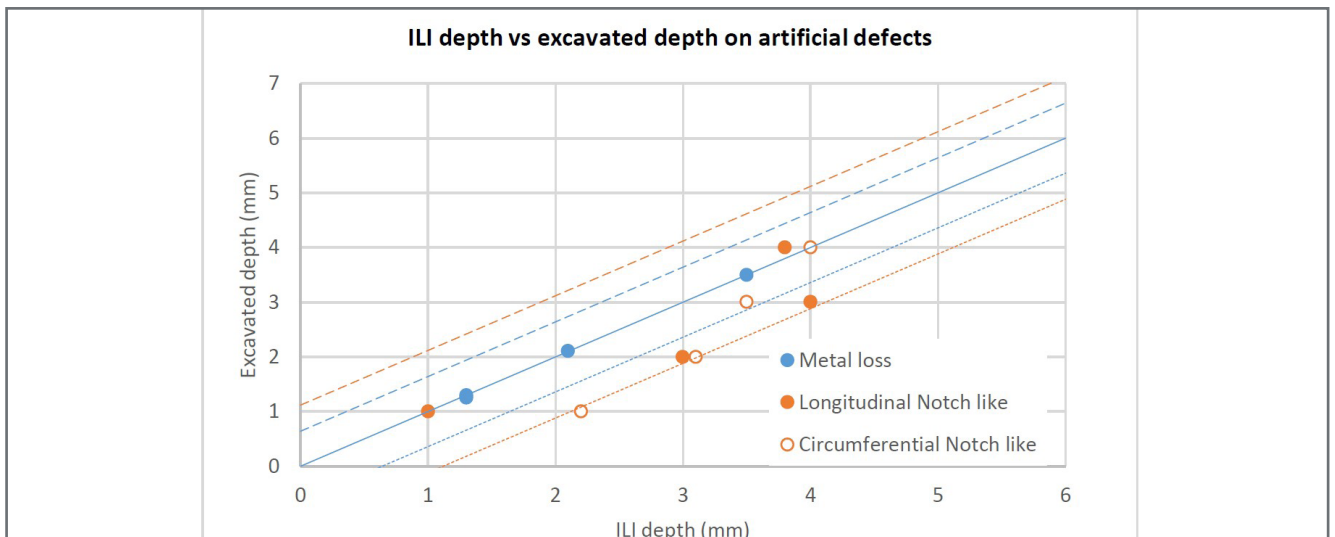
Figure 11: Sizing depth comparison between ILI tool process and excavated data on artificial defects.

Artificial defects will serve as reference points. It would be interesting to have more of these calibration reference points to improve our depth sizing chart.

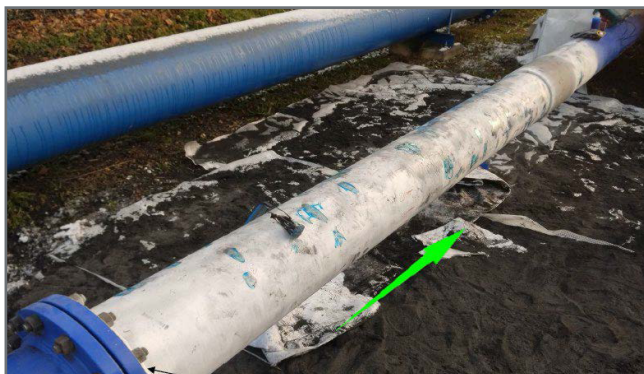
Figure 13 : Crack field pipeline section on Trapill's spool test

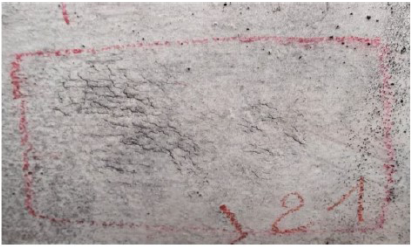
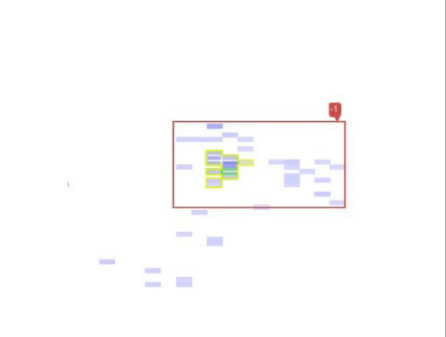
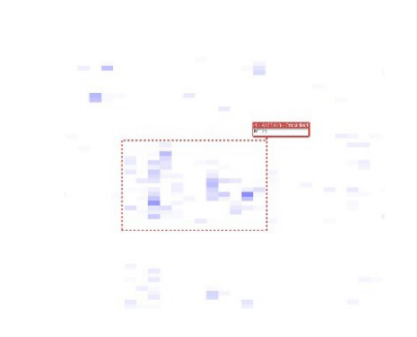
Crack on field	Crack on data analysis software (Longitudinal view)	Crack on data analysis software (Circumferential view)

Figure 18 : Example of « Spider crack » visible on both data analysis software views (Longitudinal and circumferential)

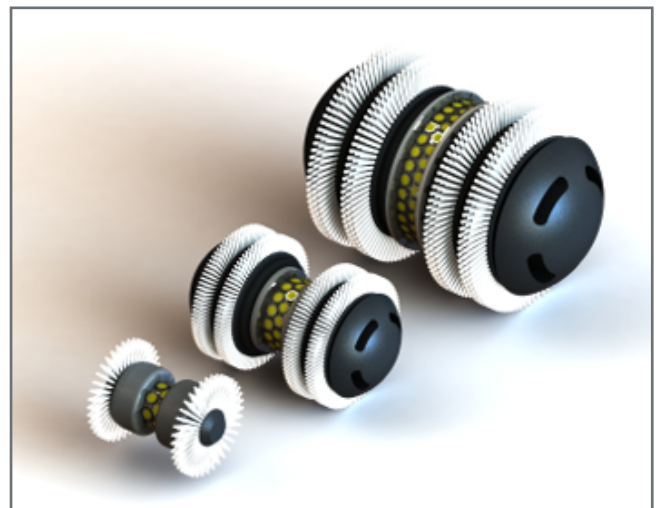
Figure 2: Image showing the different sizes of single body ultrasonic intelligent pigs.

The single body intelligent pig described here is a piezoelectric UT tooling which performs wall thickness and defect detection measurements. The centre of the intelligent pig contains the array of piezoelectric transducers, as shown in Figure 2, one end of the tool containing the controlling electronics and memory, the other end contains the power source. The pig is untethered and is propelled through the pass by water pressure. Typical inspection speeds sit between 0.3 and 0.8 ms<sup>-1</sup>, and a minimum of 15,000 internal radius and wall thickness measurements are gathered every linear metre. This range of single body intelligent pigs are suitable for inspecting tubes and pipes with diameters from 2.5 inches to 12 inches.

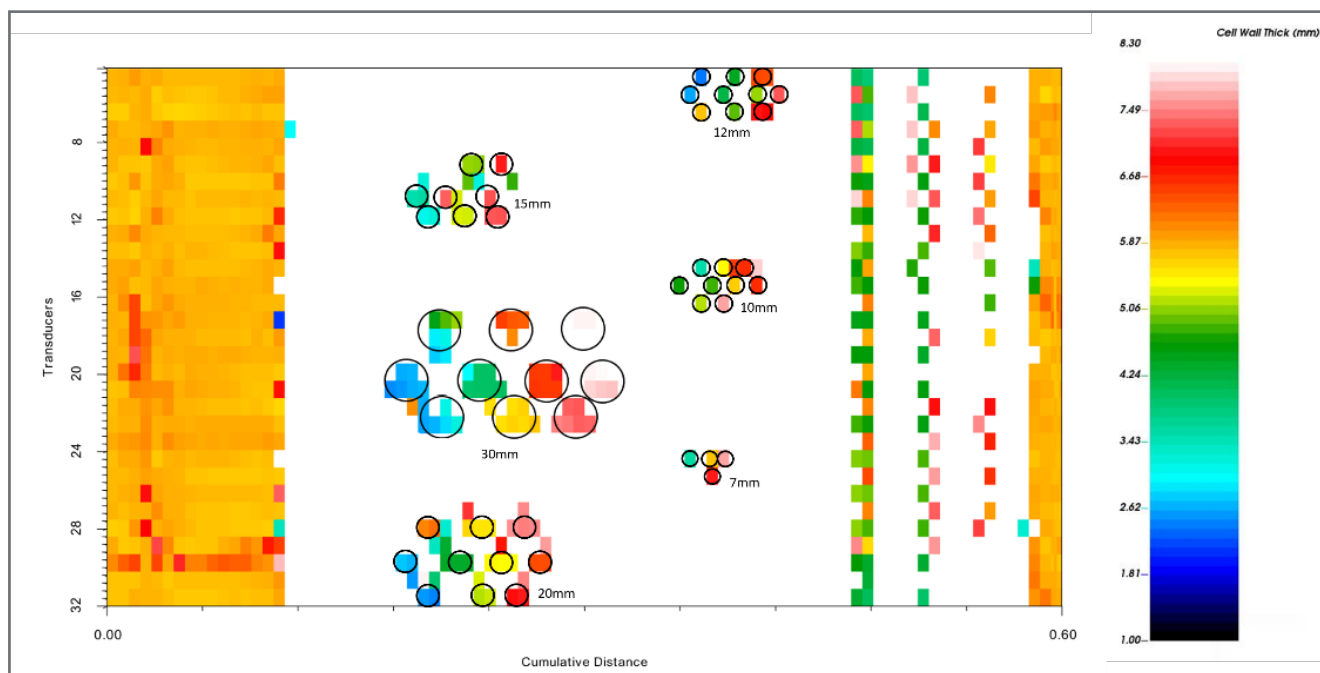
Figure 6: C-scan showing the identification of the flat bottom hole defects present in the test component.

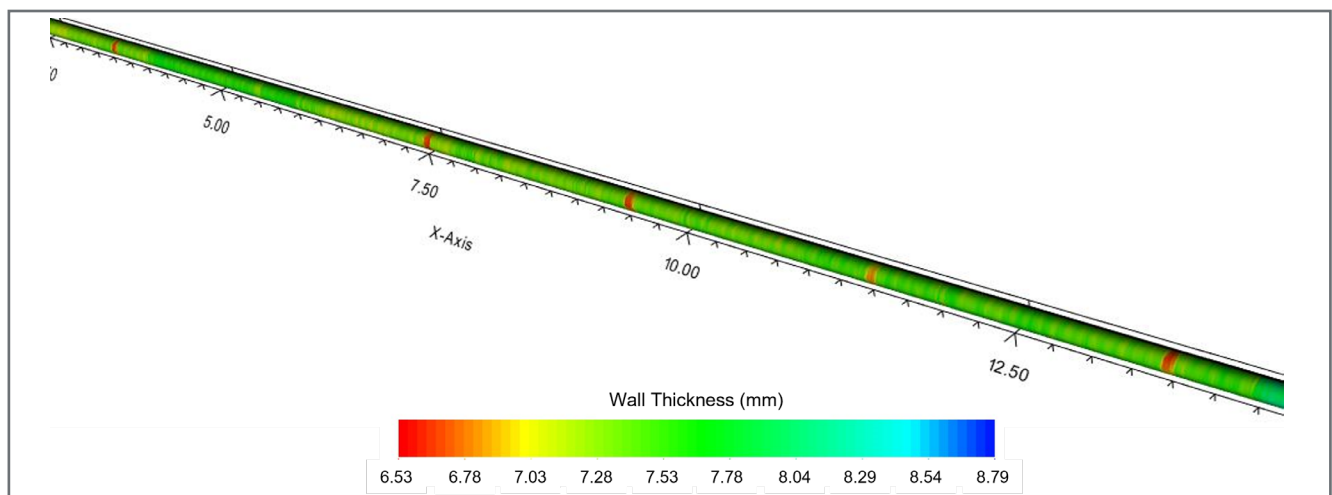
Figure 8: 3D map of the small diameter pipeline inspected using the miniaturised intelligent pig.

Following the development of the USP, a successful inspection trial was conducted. A summary of selected results is presented in Figure 8, illustrating

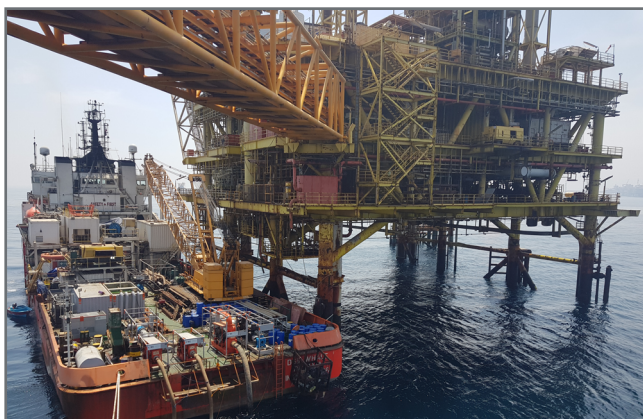
Figure 8: All Equipment onboard Offshore Vessel besides the Platform [5]

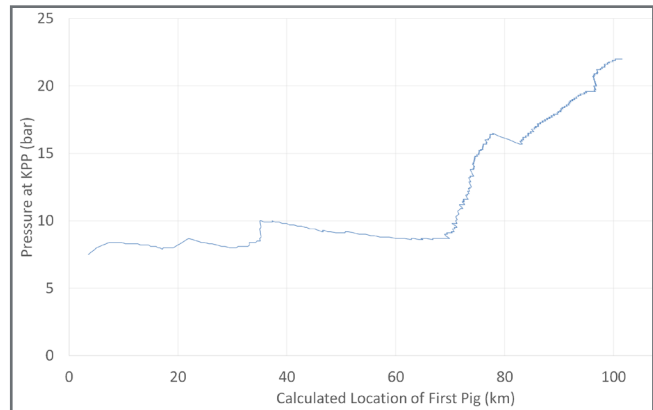
Figure 12: Calculated Location of the First Pig of Dewatering Operation [5]

As it can be seen in Figure 12, the water discharge stoppage and pipeline pressure increase has been occurred at around KP 102 of the pipeline. It can be concluded that from that moment (water discharge stoppage) the pig train has not moved. Thus, the calculated location after that point is calculation error due to compressible nature of air. In addition to that, once the pigs get stuck, some bypass flow forms around their disks. The amount of this bypass flow cannot be known without knowing the geometrical position of the pigs. But, since it is known that pigs' location is fixed and pigs are not moving, the amount of this bypass flow may be guessingly calculated by performing some numerical

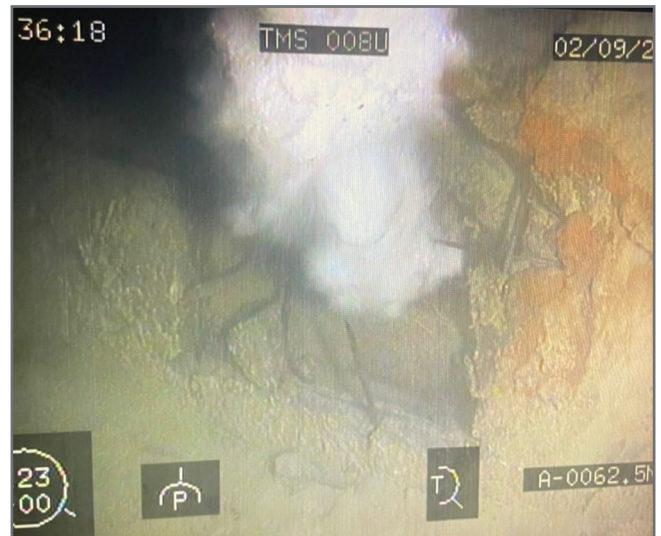
Figure 14: ROV Result on Second Damage of the Pipeline [5]

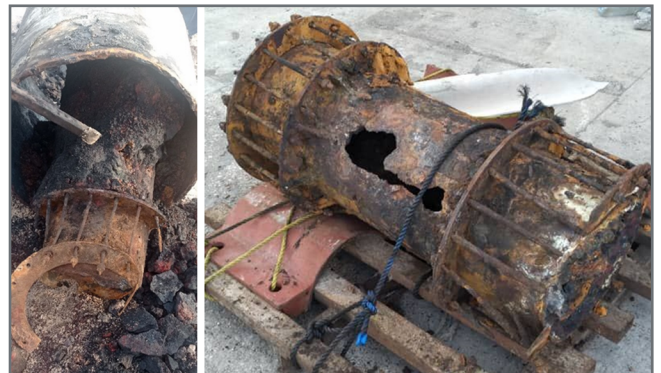
Figure 15: Recovered Stuck Pigs from Damaged Location (Third and Fourth pigs of first Dewatering Operation) [5]

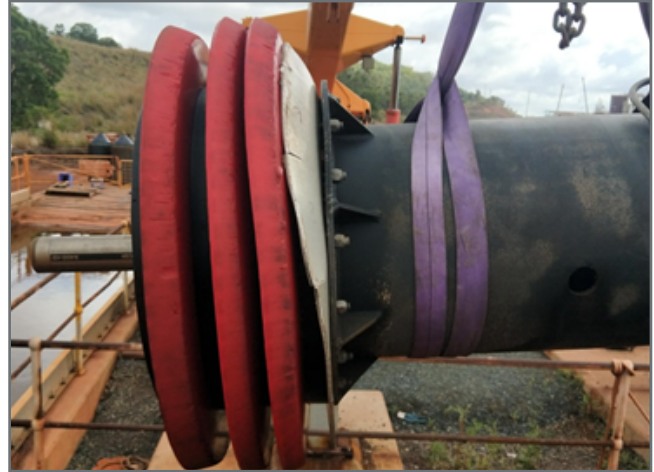
Figure 6: Damaged gauging plate
