November 2016

Pipeline Technology Journal

DEEPWATER NDT TECHNOLOGY FOR PIPES AND TUBULAR STRUCTURES

DISSECTION AND ANALYSIS OF RETIRED FLEXIBLE PIPES – KEY FINDINGS AND LESSONS LEARNED

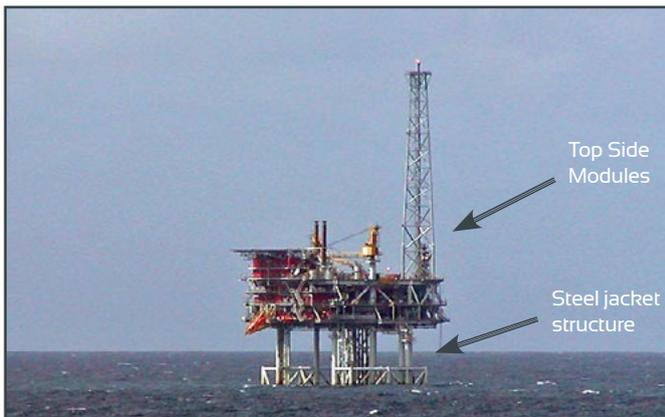
Figure 1: North Sea oil platform as seen from MS Oosterdam, clearly showing the steel jacket structures supporting the top-side modules

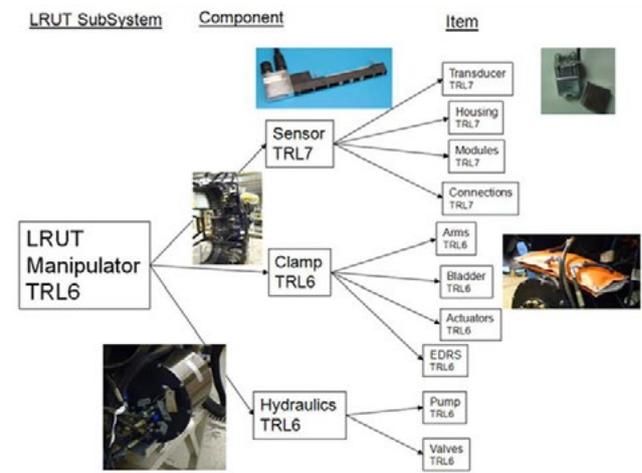
Figure 2: TRL of LRUT inspection manipulator

In following Figure 2 the TRLs (Technology Readiness Levels) of the components of the LRUT inspection manipulator are presented.

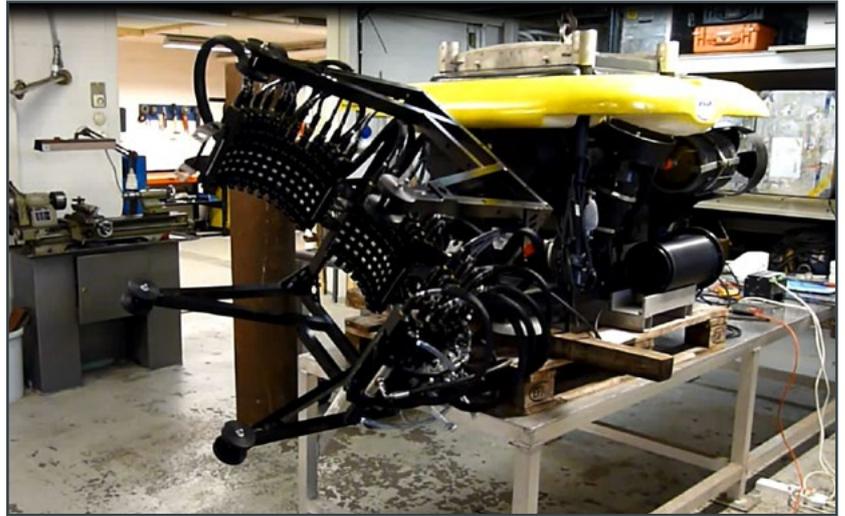
Figure 4: LRUT clamping manipulator deployed for underwater using an observation class ROV system (from DACON AS)

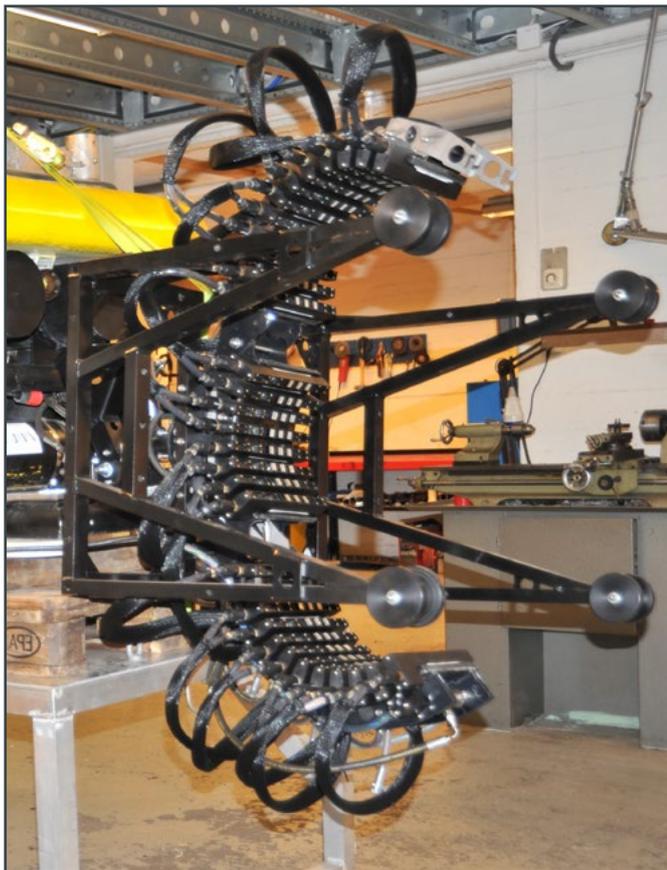
Figure 3: LRUT clamping manipulator

The LRUT clamping manipulator is already fully developed, as you can see in Figure 3 and was deployed for underwater trials and tested using an observation class ROV (from DACON AS) system, see Figure 4. This technique is at TRL6 targeting to reach a higher TRL with this current SubCTestDEMO project.

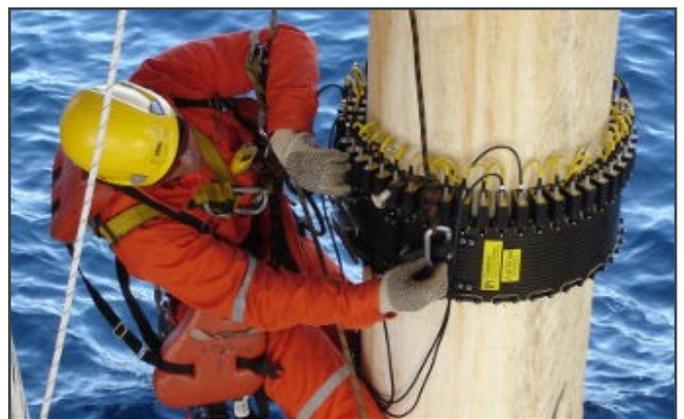
Figure 5: Plan Integrity Limited, Teletest Focus application

The LRUT technology used is a marinised version of the LRUT collar used in the commercially available LRUT equipment as seen in Figure 5, from Plan Integrity Limited; namely 'Teletest Focus'. This was the first commercially available system to utilise long-range guided wave ultrasonic testing for detecting corrosion in pipelines. The technique therefore has proven reliability.

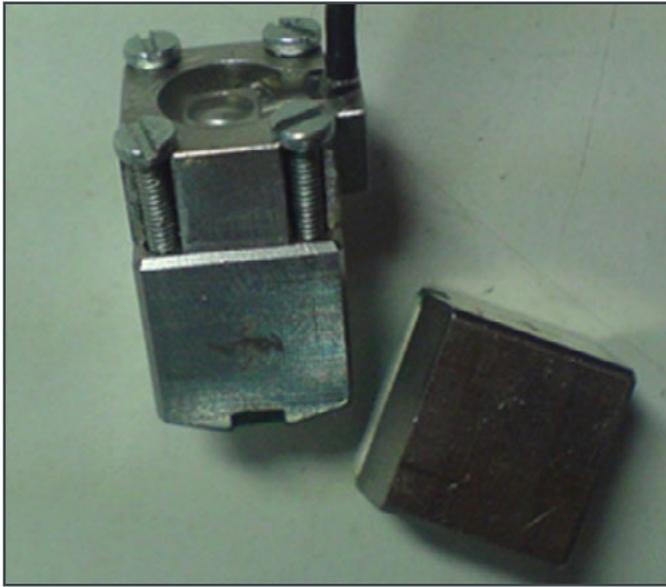
Figure 6: Marinated acoustic shear transducer

The most significant difference on this new system is the marinised version of the shear acoustic transducers which have been developed specifically for underwater applications, Figure 6.

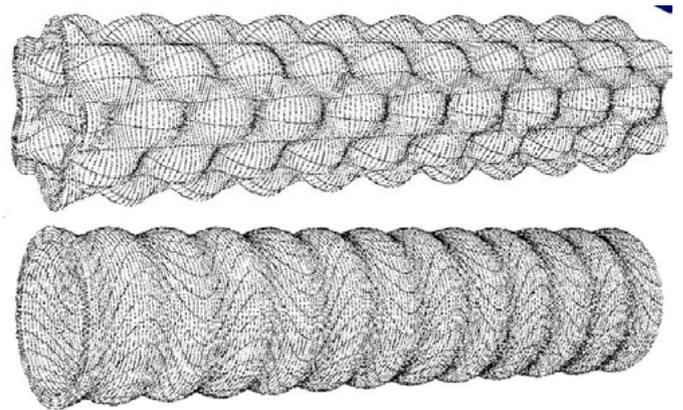
Figure 7: guided wave modes: (a) [above] Longitudinal waves and (b) [below] Torsional waves

Torsional waves were selected for SubCTestDEMO and therefore the transducers are orientated circumferentially. The transducer modules allow the transducers to be removed and replaced axially, if L-waves are chosen as the preferred mode. Both wave modes require two sets of transducer rings around the pipe, working in anti-phase to destructively interfere with the wave propagating in the opposite direction to the forward test direction. The phasing is then reversed to propagate the waves in backward test direction. The longitudinal wave operation requires a third ring to remove the $L(0,1)$ mode.

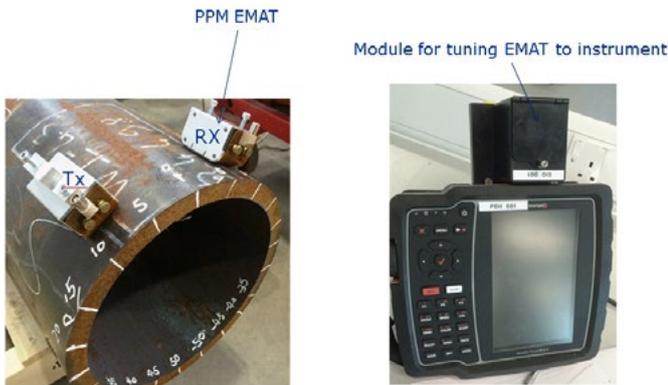
Figure 8: Experimental setup for corrosion defect detection with PPM EMAT sensors

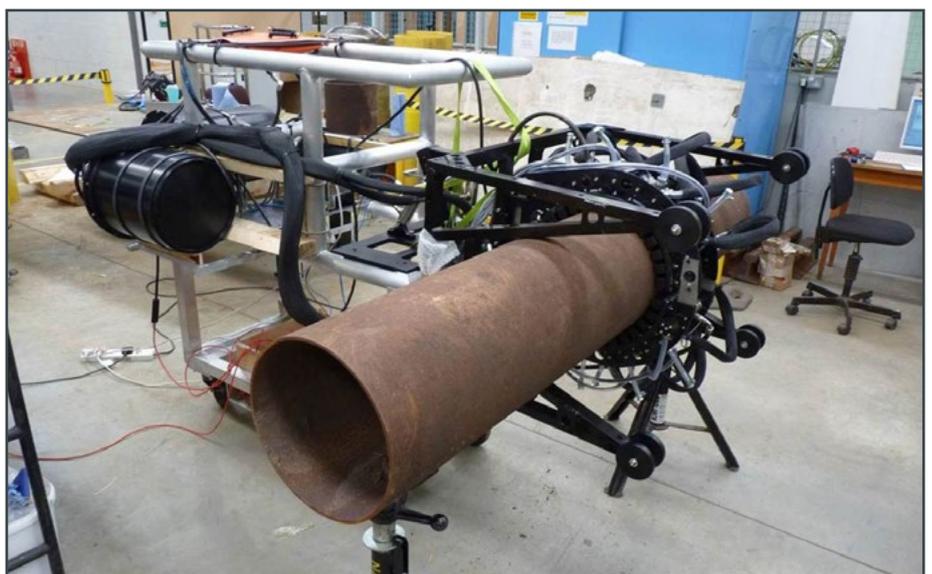
Figure 9: LRUT clamping system, mounted in a testing frame

As presented above, the LRUT clamping system is fully developed and ready to deploy in a commercial work-class C ROV, Figure 9. The LRUT manipulator is in the form of a bracelet, with a mechanism to clamp the rings of the LRUT transducers down and around the pipe, once they have been positioned by the ROV.

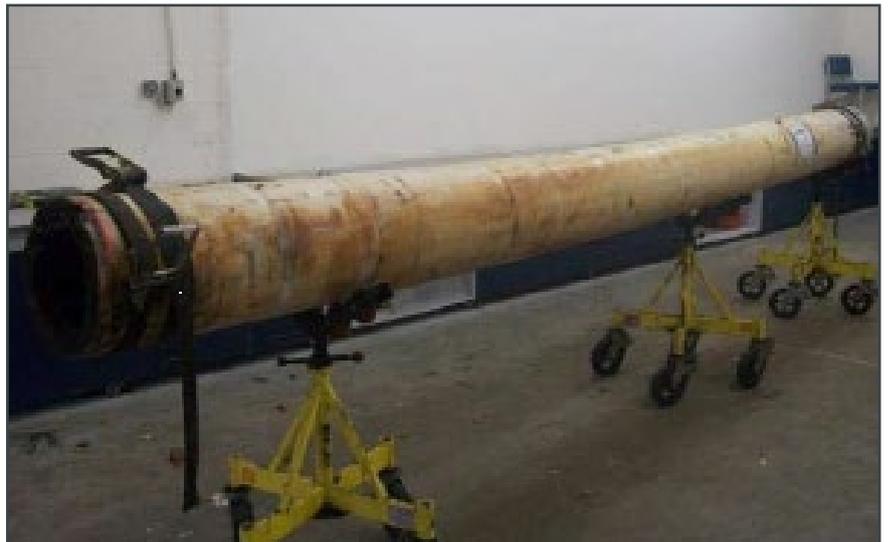
Figure 1: Mounting of Flexible Pipes for Dissection

To facilitate dissection the test pieces were mounted on telescopic vertical jacks, with both ends strapped (see Figure 1). To aid recording of the findings every layer was marked with four reference lines along the pipe lengths; the lines were equally spaced around the pipe circumference and had distance markings. During dissection each layer was subject to visual inspection from inside and outside. In addition, a spot microscopic examination and mechanical testing were carried out for carcass and armour wires, while Corrected Inherent Viscosity (CIV) testing and cross profile measurements were carried out for the pressure sheaths. Microscopic examination aimed to quantify general corrosion (all dissected risers were flooded or partly in service), while CIV testing aimed to ascertain ageing of the PA-11 material. For the jumper, the scope also included vent port communication test and function testing of the gas relief valves (GRVs).

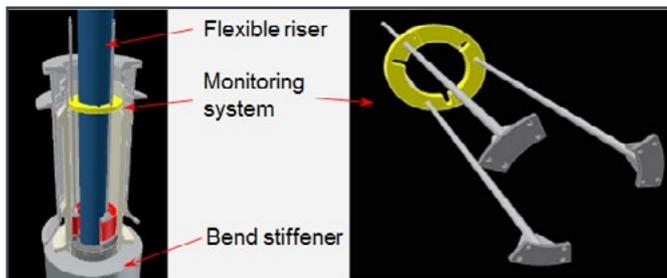
Figure 3: Bend Stiffener Monitoring System Components

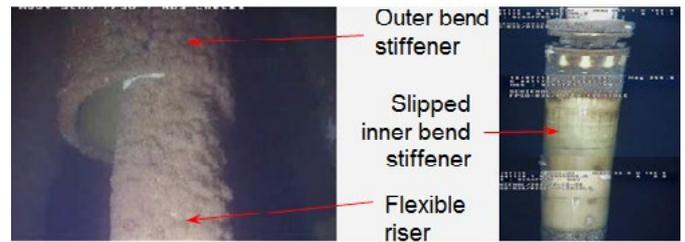
Figure 4: Slipped Inner Bend Stiffener on R2 (circa 150 meters below waterline)

The outer sheath damage on the R2 riser is thought to have been caused by the failed inner bend stiffener (see Figure 4), which lead to wear (abrasion) of the outer sheath against the outer bend stiffener and, consequently, exposing the outermost tensile armour layer to oxygenated marine environment. Microscopic examination of the wires showed some evidence of plastic deformation, which could have been due to excessive bending of the riser at the bend stiffener location following slippage of the inner bend stiffener. Slippage of the bend stiffener was identified during the routine GVI; however damage to the outer sheath was only identified during the dissection process. Routine annulus vacuum testing was not carried out through the service life of the riser (riser damaged on installation, see Table 1); however doing so would have identified the outer sheath damage at the bend stiffener area when it occurred.

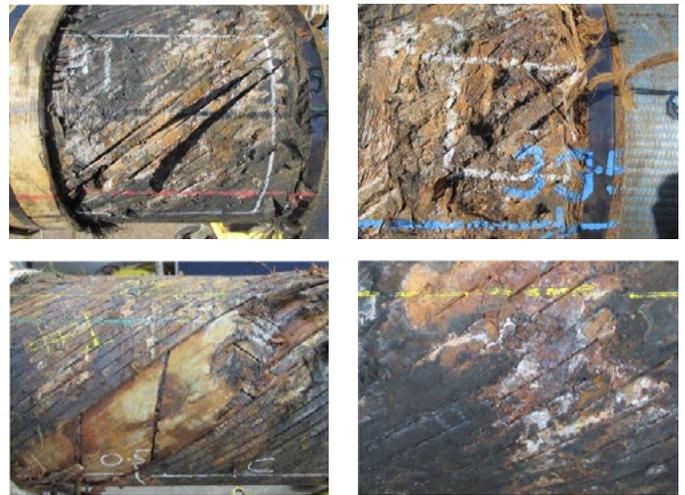
Figure 5: Major Outer Sheath Damage on the Outermost Tensile Armour Wires of R1 (top) and R2 (bottom)

Significant corrosion and broken outer tensile armour wires were identified in the areas of major outer sheath damage on the test pieces from the R1 and R2, as shown in Figure 5.

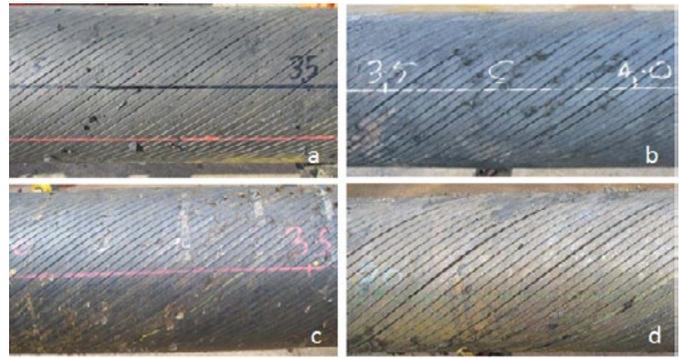
Figure 6: Outermost Tensile Armour Wires Remote from Areas of Outer Sheath Damage on R1 (a) and R2 (b), and Outermost Tensile Armour Wires on R3 (c) and R4 (d)

Flexible pipes are fitted with a CP system designed to provide protection from marine corrosion for the exposed armour wires in case of outer sheath damage. The dissection findings suggest that CP systems did not provide protection to the areas of major outer sheath damage on R1 and R2. This is likely to be due to the fact that both areas were remote from the locations of the anodes (circa 700 m) and "shielded" by the bend stiffeners.

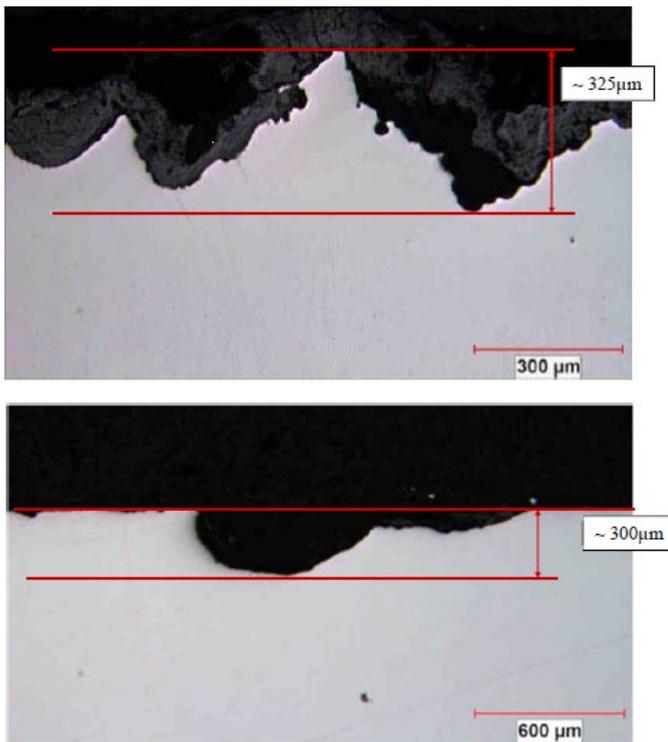
Figure 7: Examples of Pitting Measurements: 2nd Tensile Armour Wire from R1 (top) and 4th Tensile Armour Wire from R3 (bottom)

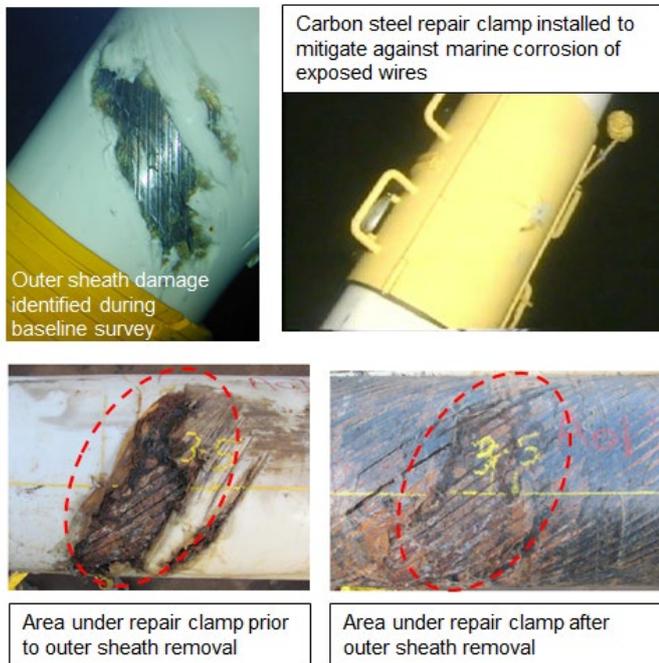
Figure 8: R2 Repair Clamp Area (Subsea)

Visual inspection of the armour wires from the R2 riser area which was covered by a repair clamp in service showed moderate localised marine corrosion (see Figure 8). Corrosion was less severe when compared to that observed in the areas of major outer sheath damage (see Figure 5). The latter is consistent with the fact that the damage to the outer sheath was identified and clamped shortly after the occurrence (circa 1 month), and location of the damage was at circa 400 m below the waterline (i.e. less oxygenated environment). Considering that the repair clamp was fitted promptly, the observed corrosion under the clamped area suggests that the clamp did not fully seal the damaged location – presumably because the rigid clamp was relatively long and located on a dynamic section of the riser (near to touch down).

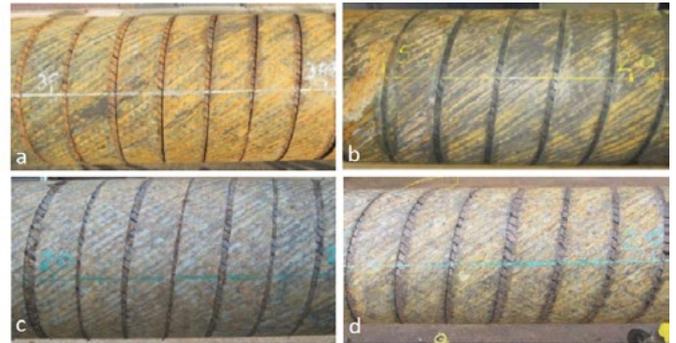
Figure 9: Outermost Anti-Wear Tapes of a) R1 b) R2 c) R3 and d) R4

The annuli of the R1 and R2 risers were flooded to the waterline, while the annuli of the R3 and R4 risers were partly flooded when in service. During ongoing risk assessment of failure mechanisms, cracking was not considered to be a high risk due to the relatively low operating temperatures. Examination of the anti-wear tapes during dissection confirmed this to be the case.

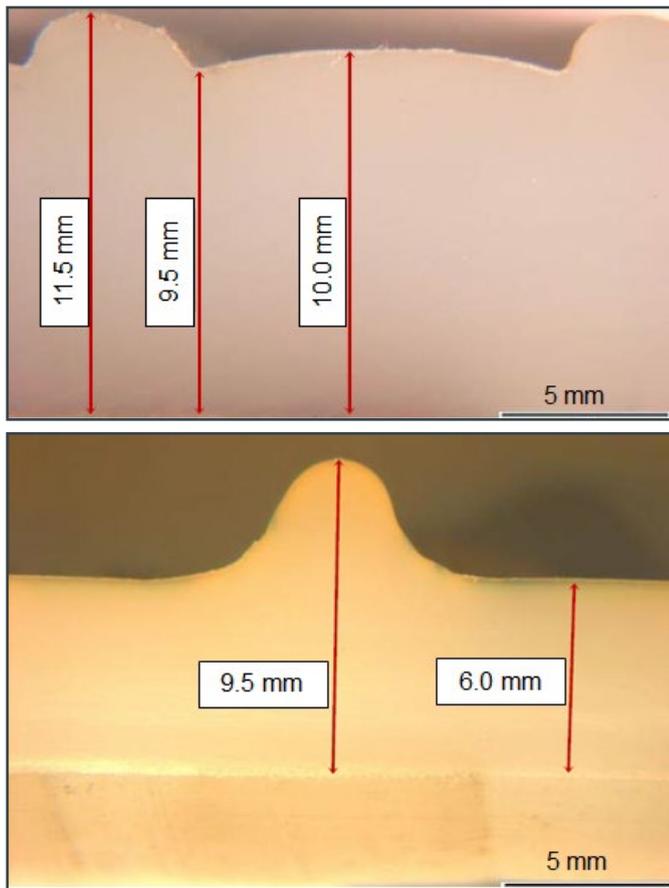
Figure 10: Pressure Sheath Profile from R2 (top) and R4 (bottom)

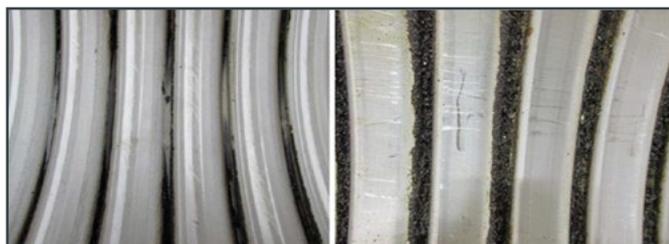
Figure 11: Inner Surface of Carcass from R1 (left) and R3 (right)

The carcass layer removed from all test pieces was found in good general condition with no damage observed. Some evidence of erosion was observed on the inner surfaces of the carcasses from production risers (see Figure 11), which was considered to be consistent with the sand levels and flowrates recorded in service. The absence of carcass defects is consistent with experience from similar riser systems in the North Sea [1]. A large number of carcass tearing and collapse incidents have been reported recently for the risers removed from offshore developments in the Norwegian sector of the North Sea [6]; they were associated with multilayer PVDF pressure sheath material, which was not used on any of the risers discussed in this paper.

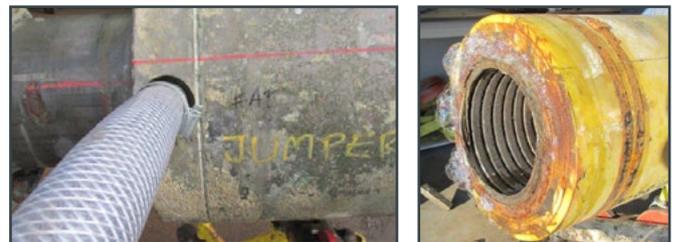
Figure 12: J1 Vent Port Communication Test: Hose Arrangement (left) and Air Bubbles Confirming Positive Communication (right)

Vent port communication test has been carried out on the end-fitting from the J1 jumper. This involved removal of the GRVs, then connecting hoses with a supply of compressed air, as shown in Figure 12 (left). The cut surface opposite the end fitting was dosed in clean soapy water and then air was gradually introduced into the hoses (< 1 bar). Air bubbles started forming within 1-2 seconds, thus confirming communication between the vent ports and the jumper annulus, as shown in Figure 12 (right).

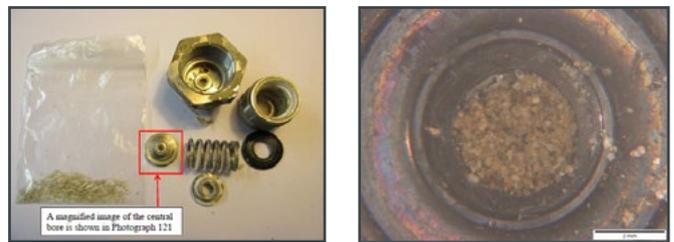
Figure 13: J1 GRV Examination: Debris Contained within GRV (left) and Magnified Image of the Central Bore (right)

The GRVs removed from the end-fitting were subject to pressure testing to confirm their functionality, and both failed to open (two tests, up to 4 bar and up to 6 bar maximum pressure, respectively). Further examination of the GRVs showed accumulation of debris, as shown in Figure 13. Accumulation of marine growth and/or soil in the GRVs of flexible pipes over time has been acknowledged by the industry [7].

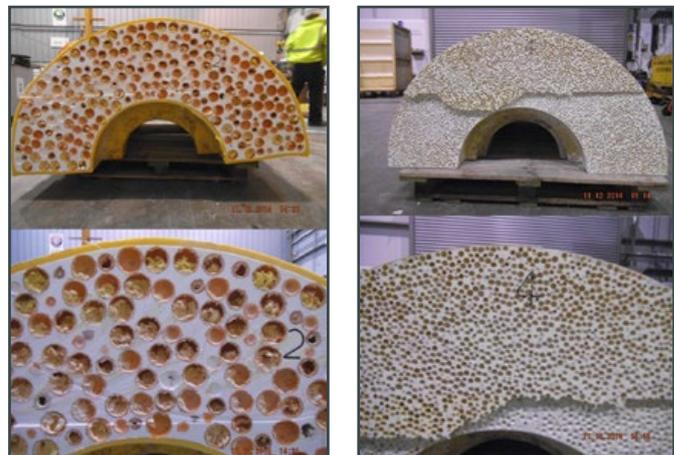
Figure 14: Distribution of Macro Spheres in R1 (Left) and R4 (Right) Buoyancy Modules

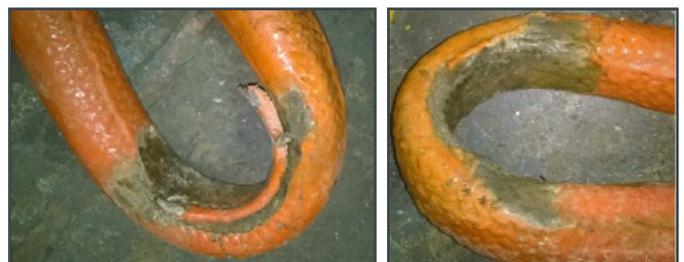
Figure 15: Damage at Soft Eye Bearing Points of R1 Upper Tether Clamp Tethers

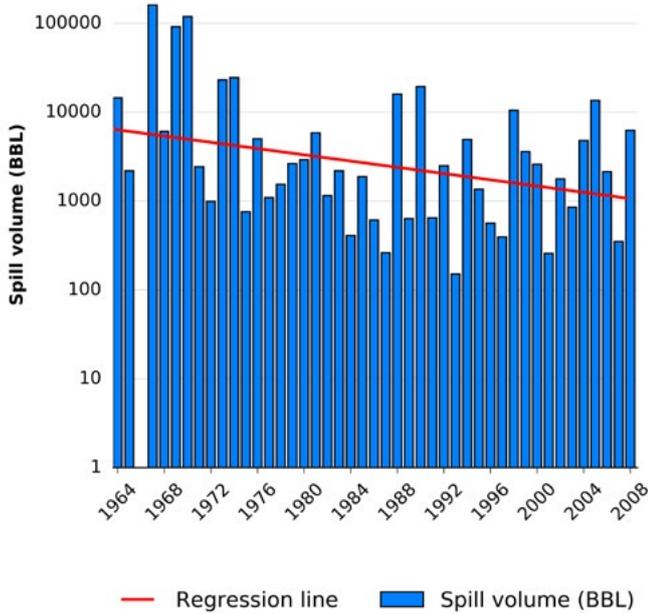
Figure 1: Spill volume for the Gulf of Mexico, 1964-2008 (BSEE, 2011)

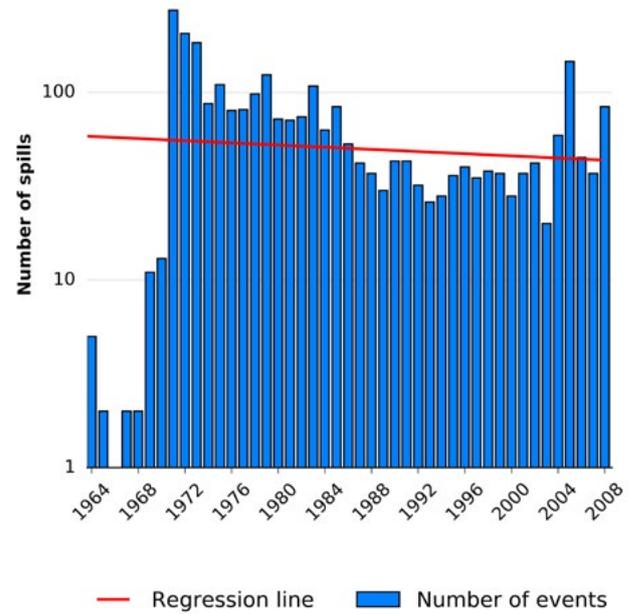
Figure 2: Spill incidents for the Gulf of Mexico, 1964-2008 (BSEE, 2011)

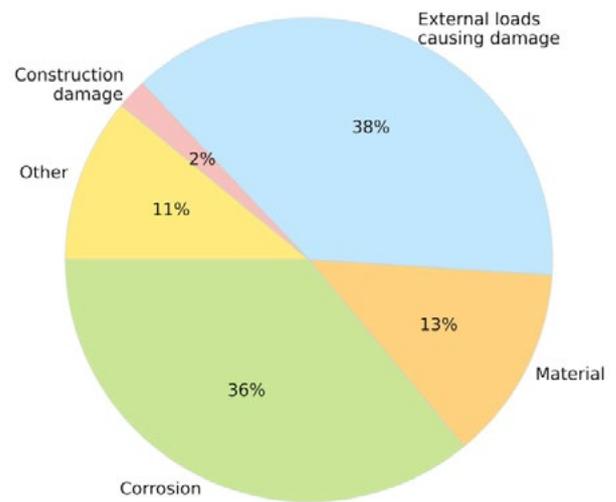
Figure 3: Cause of failure of offshore oil and gas infrastructure in the Gulf of Mexico (BSEE, 2011)

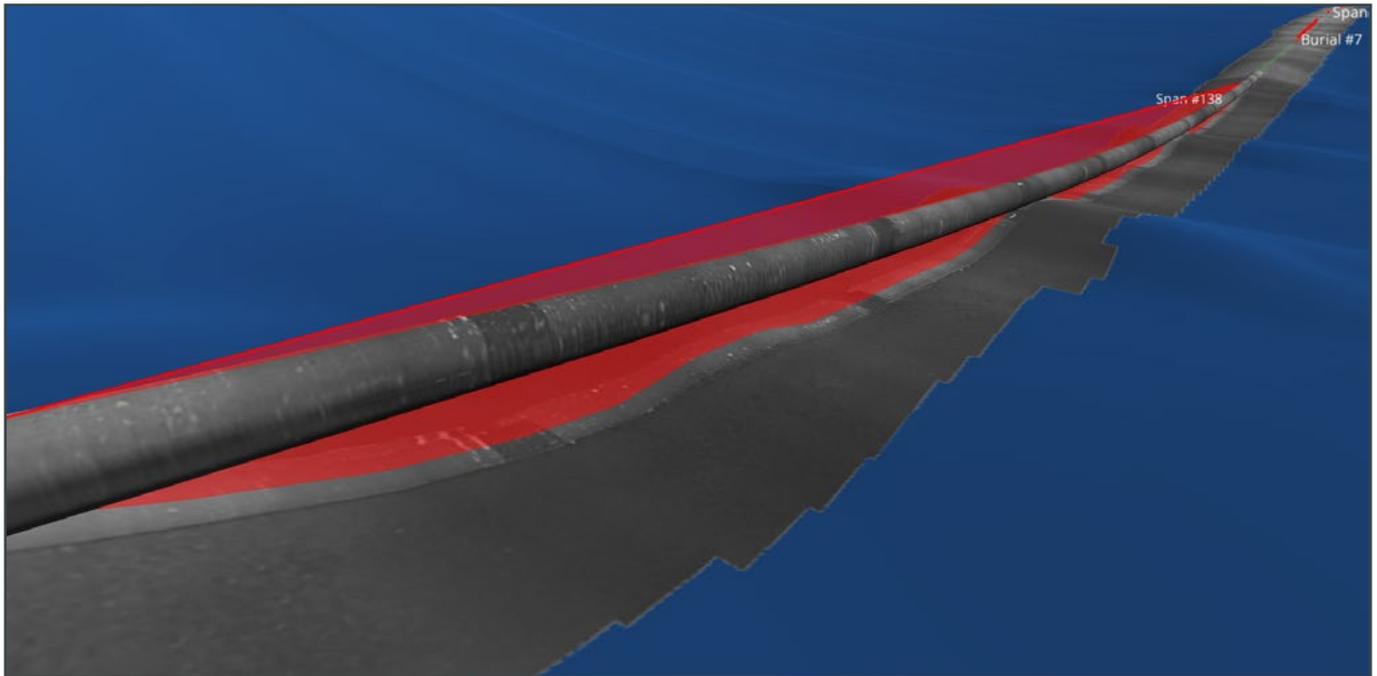
Figure 6: Web based Roames visualization of the physics enabled pipeline model created automatically using data collected using an AUV (location: North Sea)

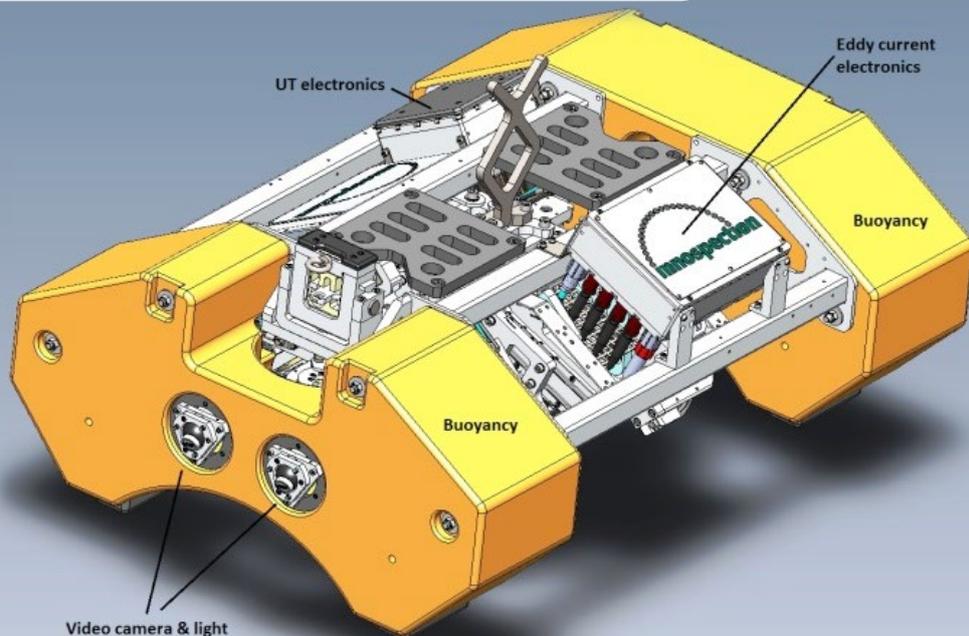
Figure 1: The MEC™-Combi Crawler tool for the inspection of subsea pipelines

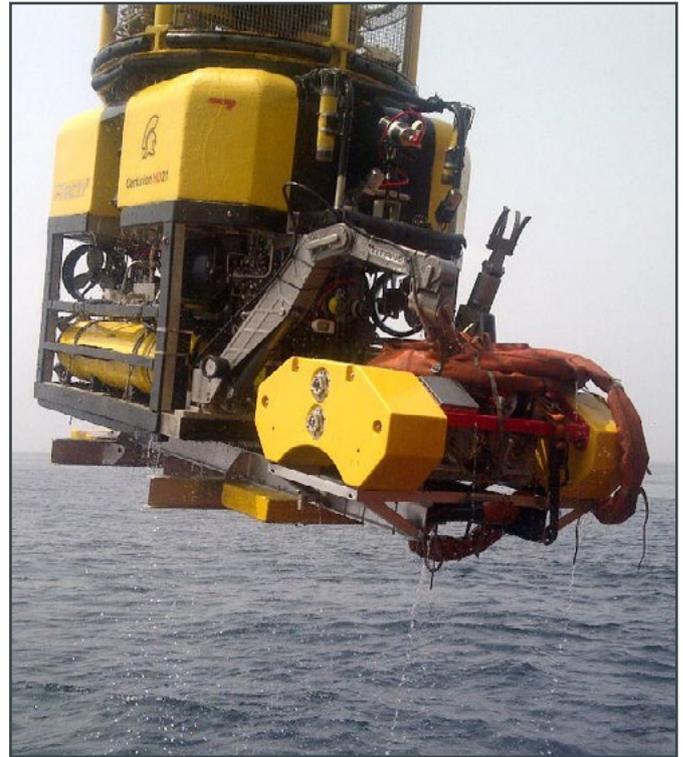
Figure 2: The MEC™-Combi Crawler on site

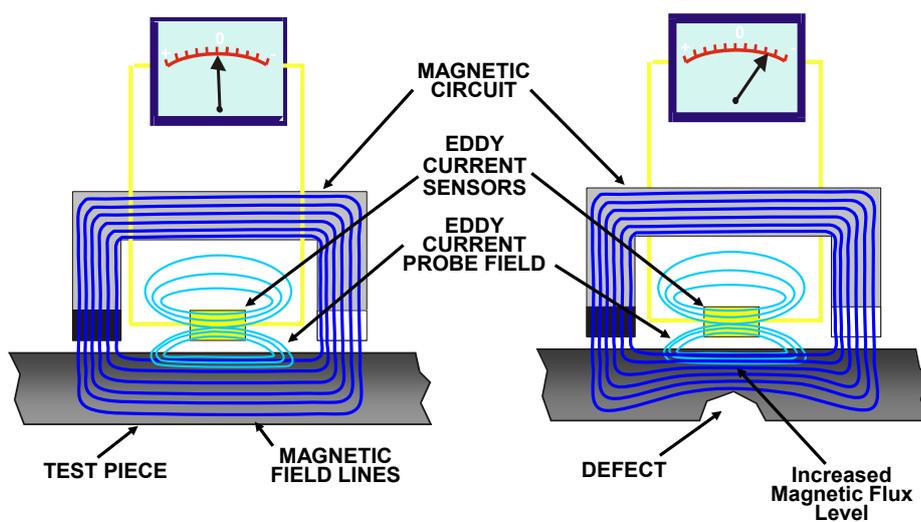
Figure 3: Principle of the MEC™ technology (Magnetic Eddy Current) also known as a further developed technique from Saturation Low Frequency Eddy Current (SLOFEC)

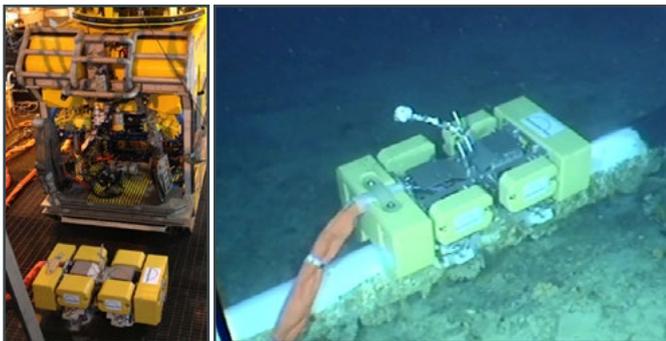
Figure 4: Left: the inspection tool (modified MEC™-Combi Crawler) lying in front of a work class ROV. Right: Tool deployed on subsea pipeline scanning over the pipeline

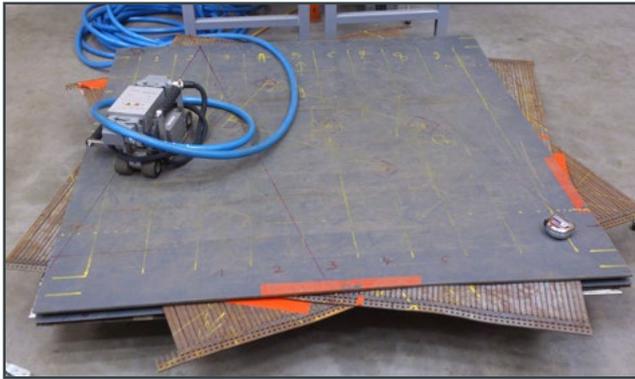
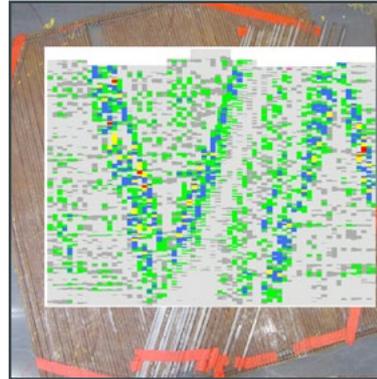
Figure 5: Set-up for testing of wire disorganization defects on a flat sample (left) and results for loose wires and wire gaps (right)

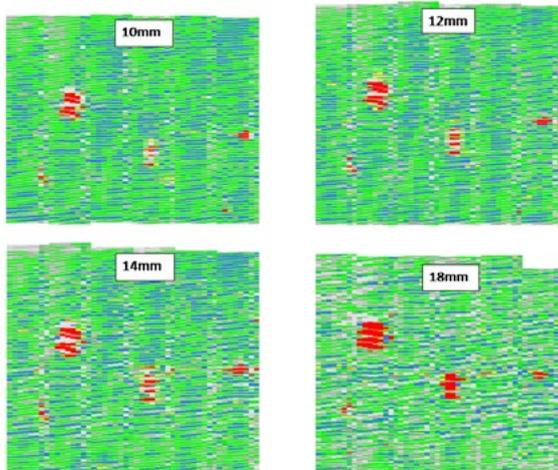
Figure 6: Obtained signals with different lift-off as indicated

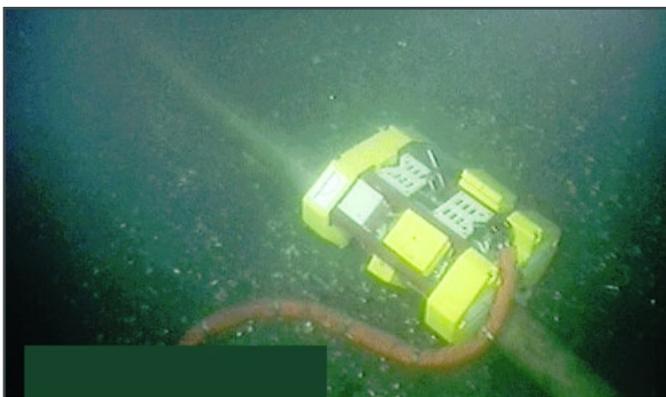
Figure 7: The MEC™-Combi Crawler on a flexible pipe carrying out the measurement

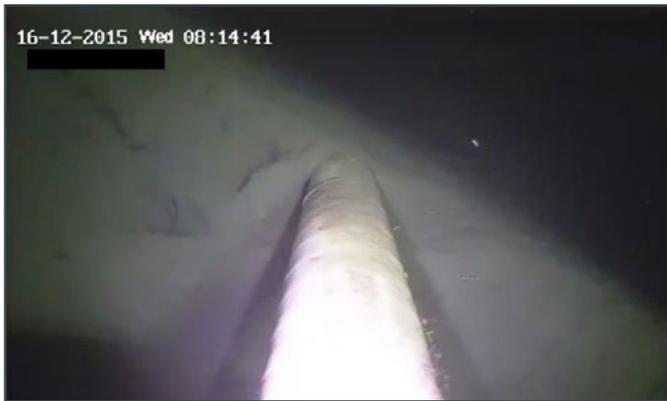
Figure 8: View of the pipe and the seabed after intervention. The picture is taken from the camera on the crawler

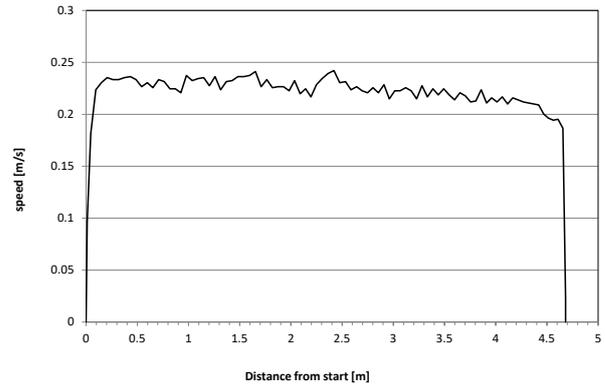
Figure 9: Speed profile of a scan

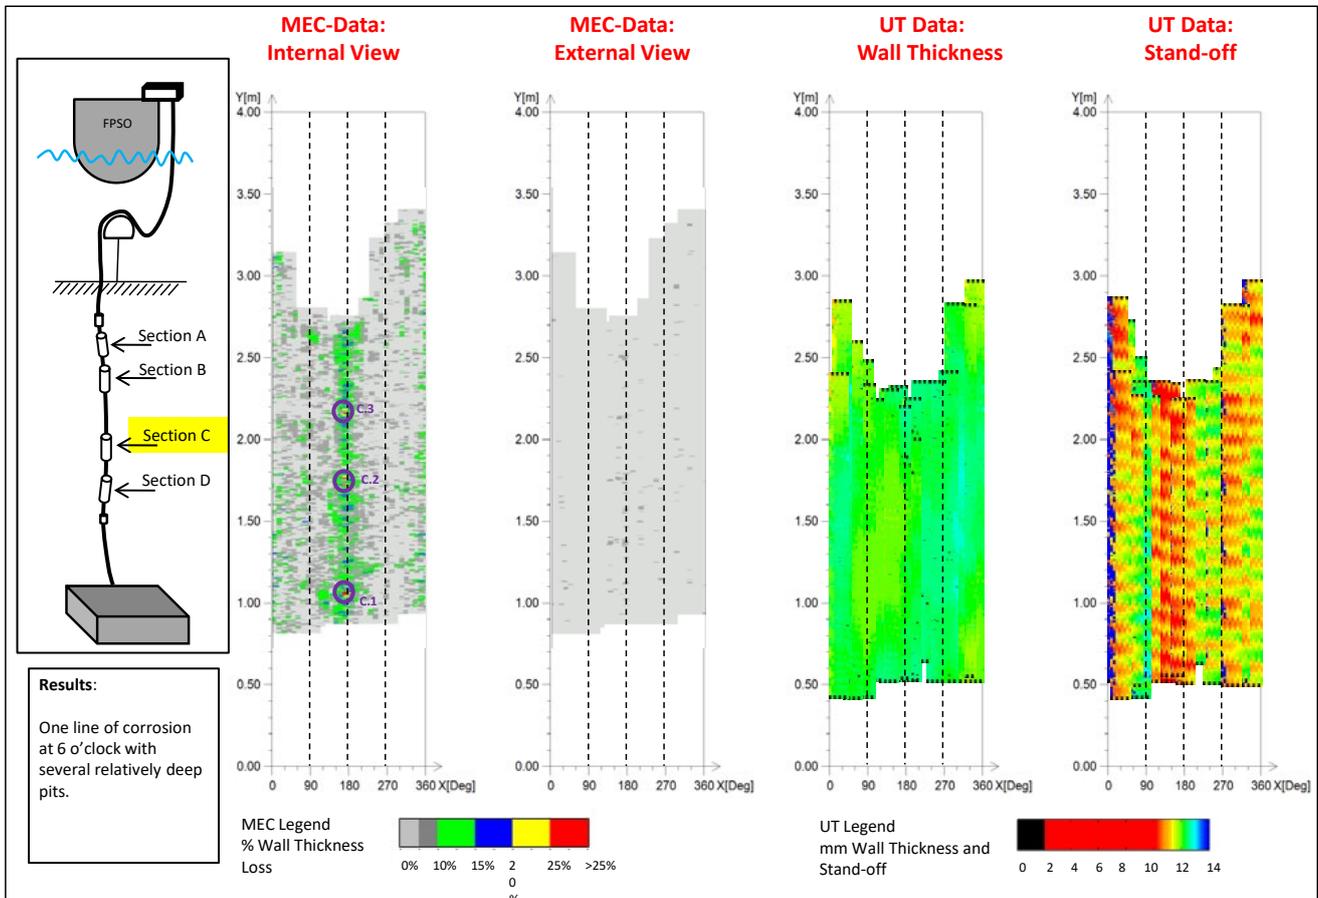
Figure 10: Sample report page for full circumference inspection of pipeline on the seabed

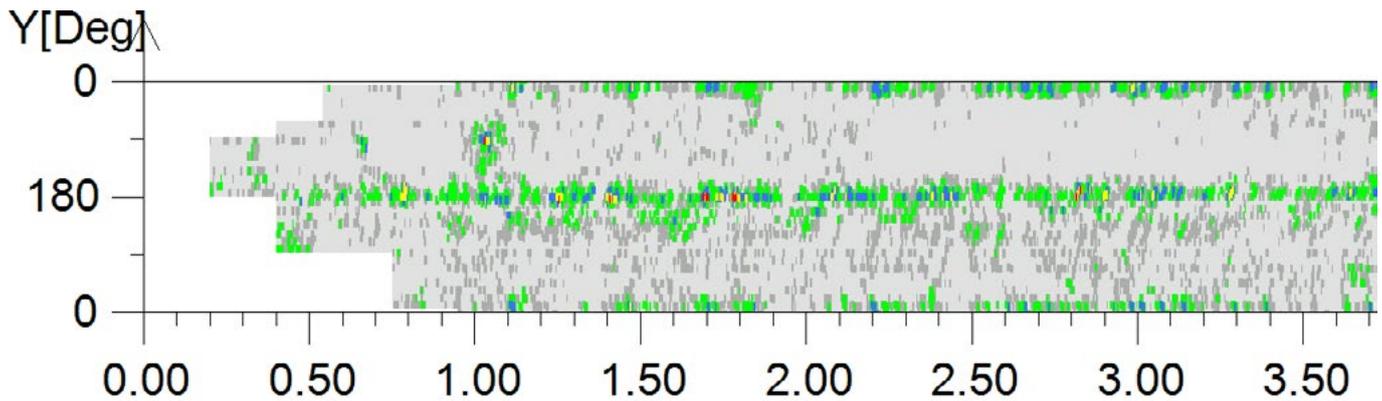
Figure 11: Full view of internal defects with MEC™
