## Integrity Management & Inline Inspection

Advances in In-Field ILI Indication and Material Verification

Long Distance Inline Inspection of an Unpiggable Natural Gas Pipeline with Robotic Technology

A New Phased Array Sensor for Pipeline Inspection – Optimization and Quantitative Performance Evaluation

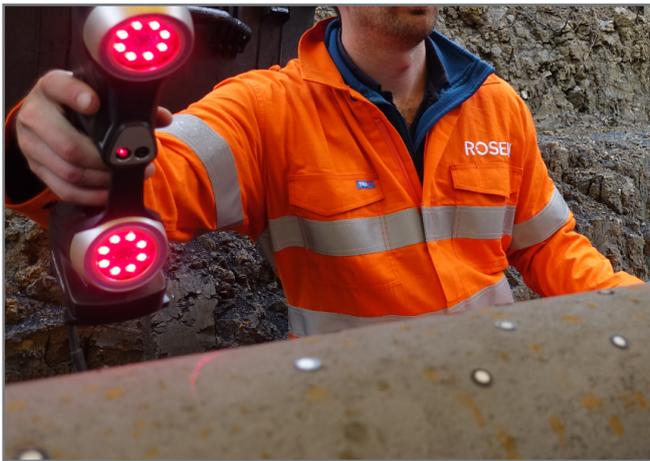
Figure 1: In-field laser scan

The past decade has seen the widespread use of laser-scan data for sizing of metal loss and geometric features in pipelines (see Figure 1). The detailed data can be interrogated to create finite-element (FE) models. Indeed, some more-modern equipment offers the capability to perform these metal loss assessments in-ditch to the more complex ASME B31G [3] Level 2 metal loss assessments. The data can also be used to remove unnecessary conservatism from empirical models, and in some cases, it can help to explain why certain features have formed where typically we would not expect to see them.

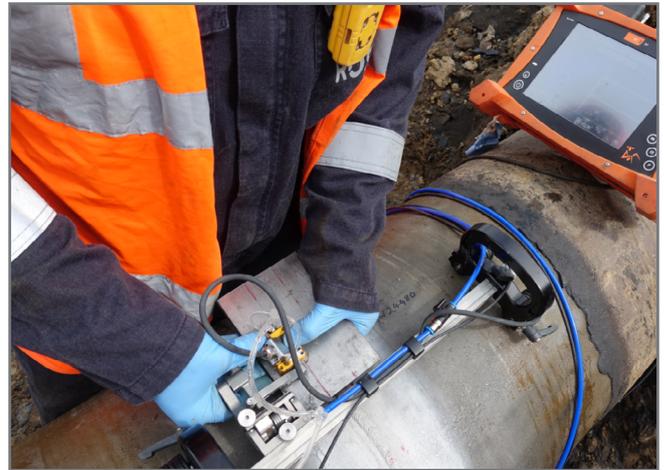
Figure 2: In-field PAUT inspection of a girth weld

Ultrasonic testing (UT) and phased-array ultrasonic testing (PAUT) are generally accepted in the industry as the “go-to” techniques for sizing crack-like indications. Identifying and sizing cracks as part of a colony with UT can be complex and challenging (see Figure 2). Even with the latest technologies, these techniques

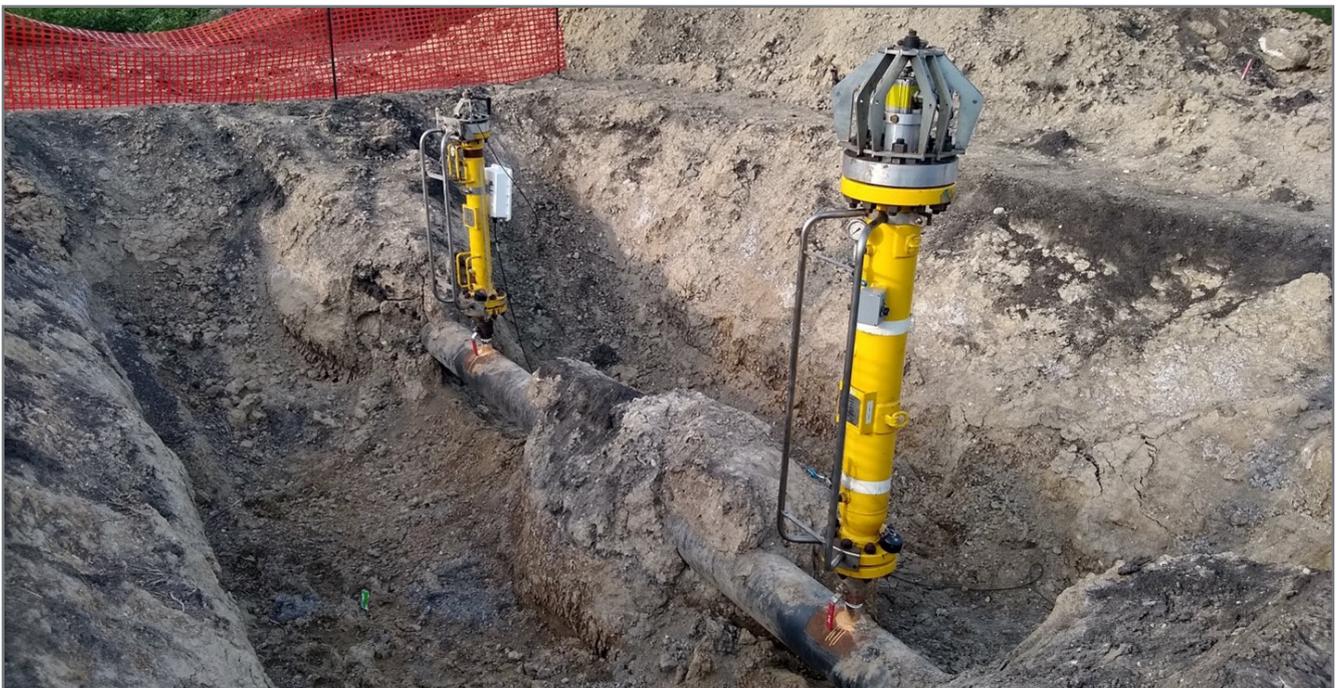
Figure 5: In-line Charge Site on 10 inch Pipeline

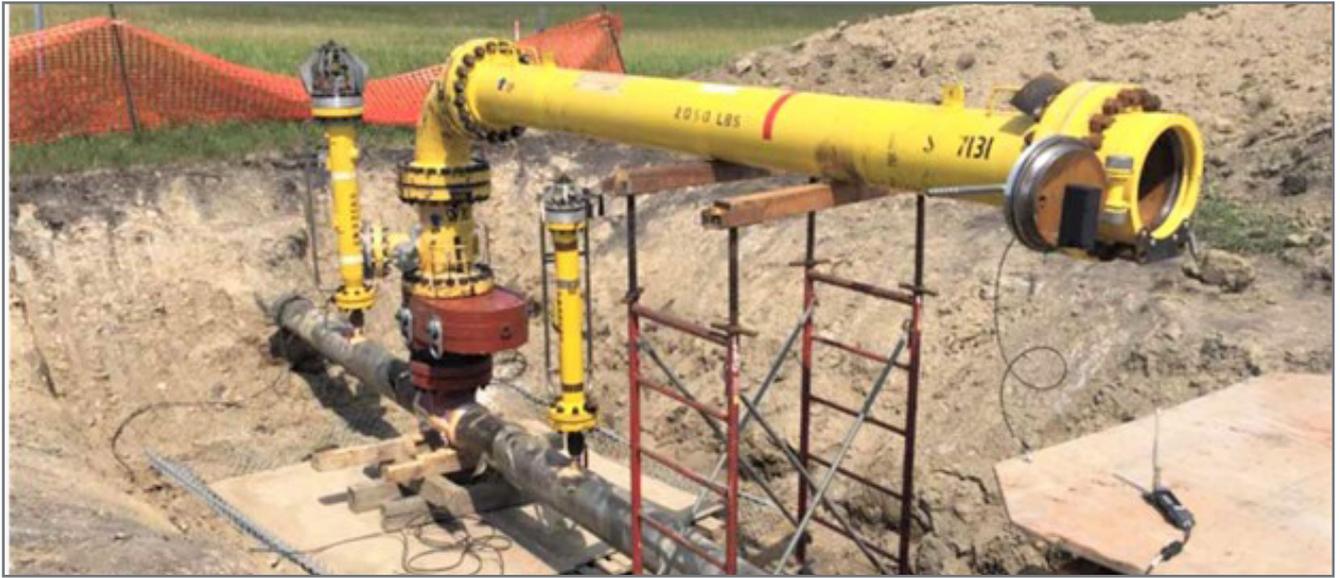
Figure 6: Intero's Launch System for Explorer 10/14

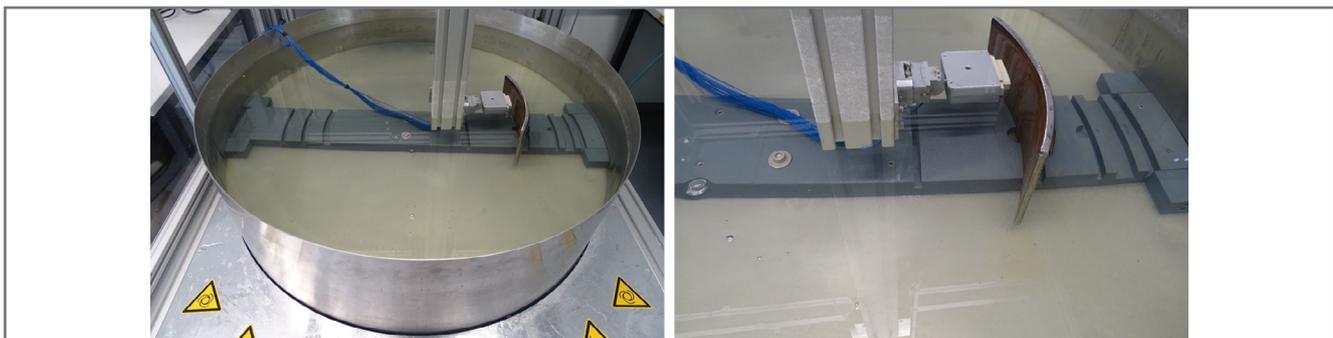
Figure 12: Lab set-up for the validation measurements consisting of the water basin, sensor holder, manipulator and mounting element for the positioning of test specimens of various diameters. In the image on the right, the prototype of the new sensor can be seen, which has been fabricated by Waygate Technologies, a Baker Hughes business (Hürth, Germany).

The validation measurements were performed in the laboratory using a test rig which allows to scan test specimens of various diameters in circumferential direction using immersion technique. The test rig is shown in Figure 12 including the measurement set-up where the sensor insonifies onto the inner surface of

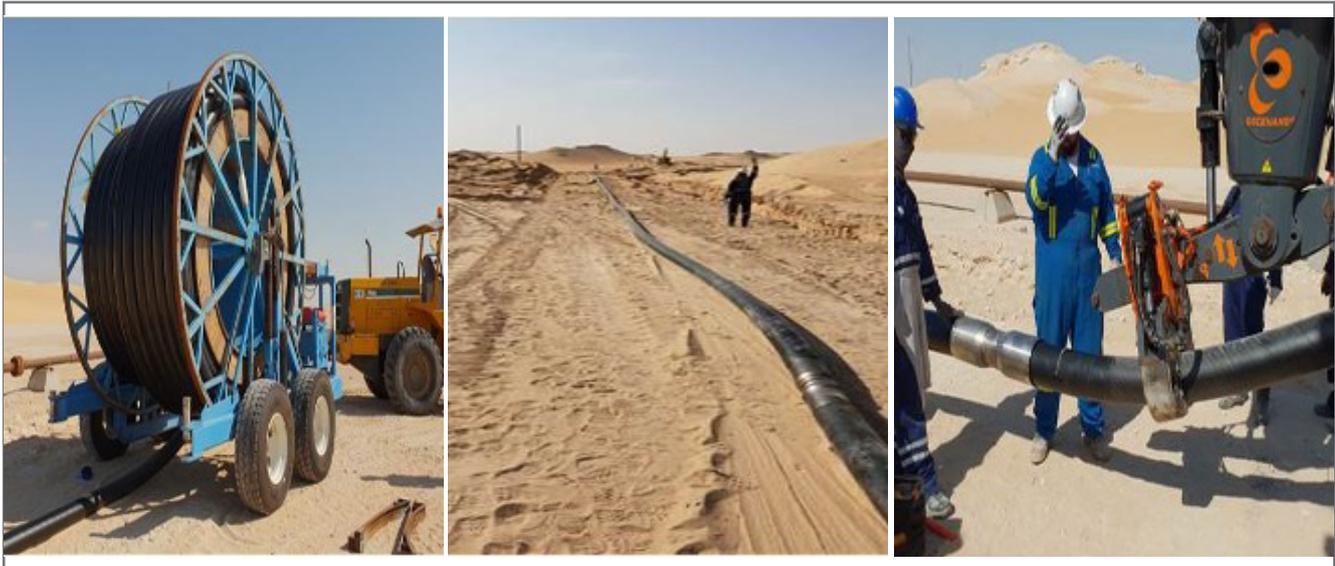
Figure 7: High Pressure RTP pipe installation

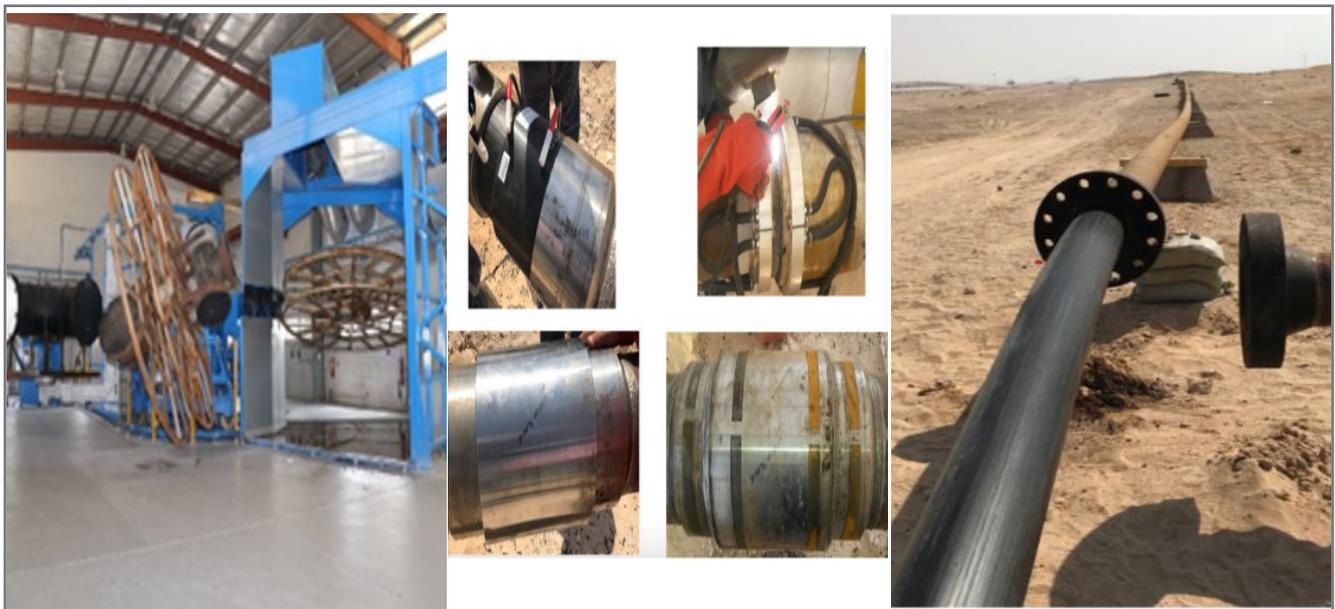
Figure 8: HDPE Lateral Rehabilitation with Coupling and Rotational Lining Process

The technology was used to rehabilitate ageing laterals lines rated at 3000psig, 70C/150F. The technology was piloted on an ageing 10” injection lateral with active internal corrosion and having over fifteen (15) sleeves with a length of around one (1) kilometer. The tight fit HDPE liner technology was successfully deployed to rehabilitate the 10” injection lateral. Rotational lining technology along with the HDPE line coupling was also successfully used for the lining of piping fittings and for replacing heavy schedule flange joints

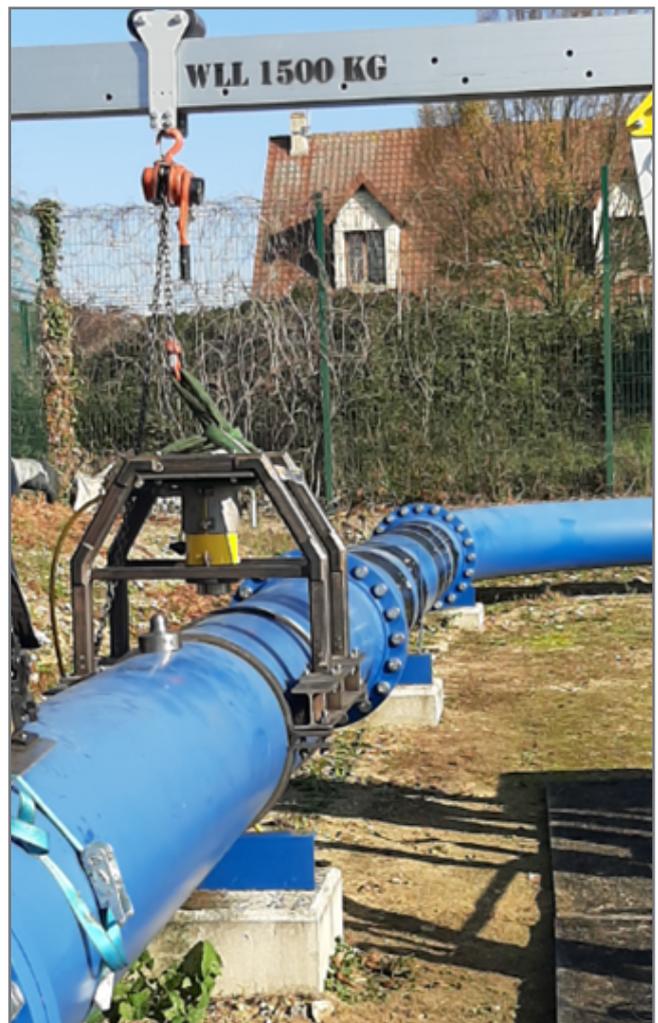
Figure 5: Hydraulic press used to simulate the dents on the pipeline

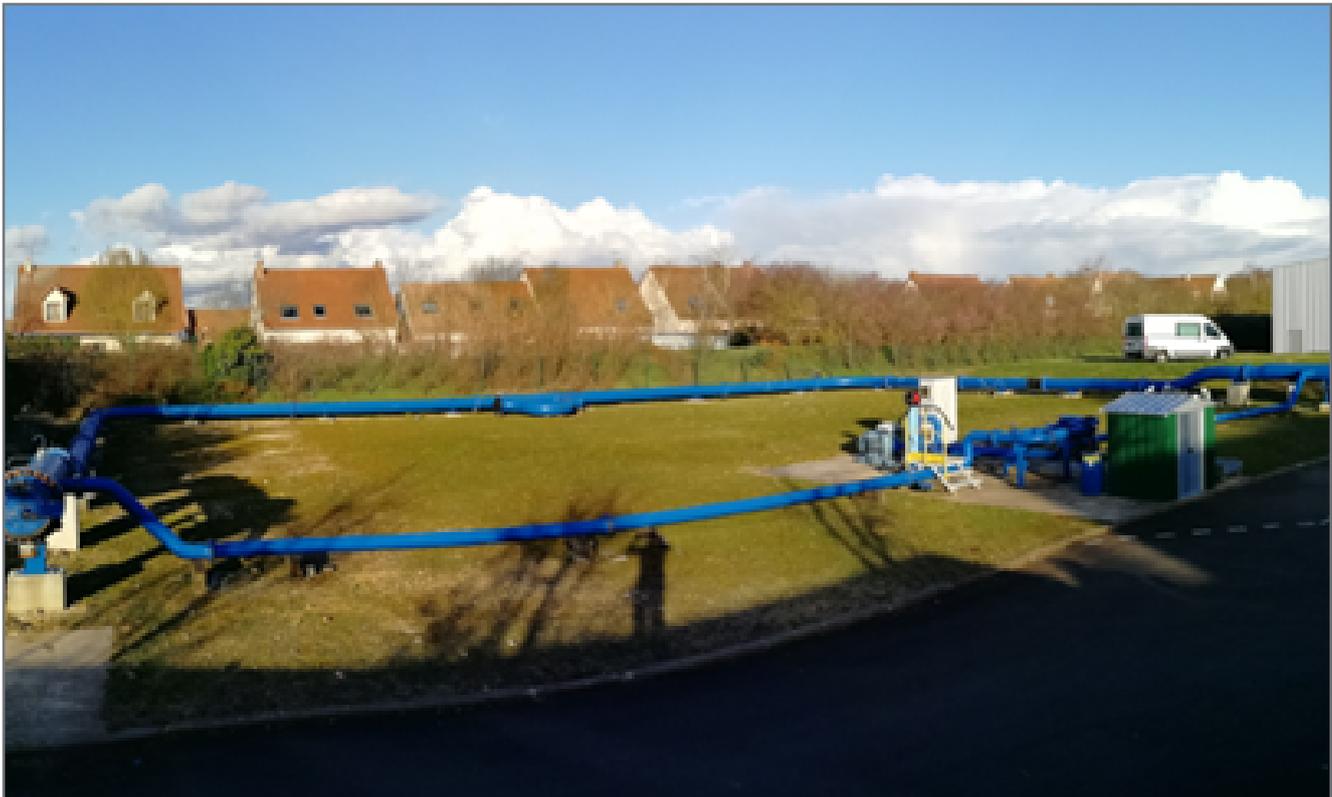
Figure 14: Hydraulic test bench in Poissy.

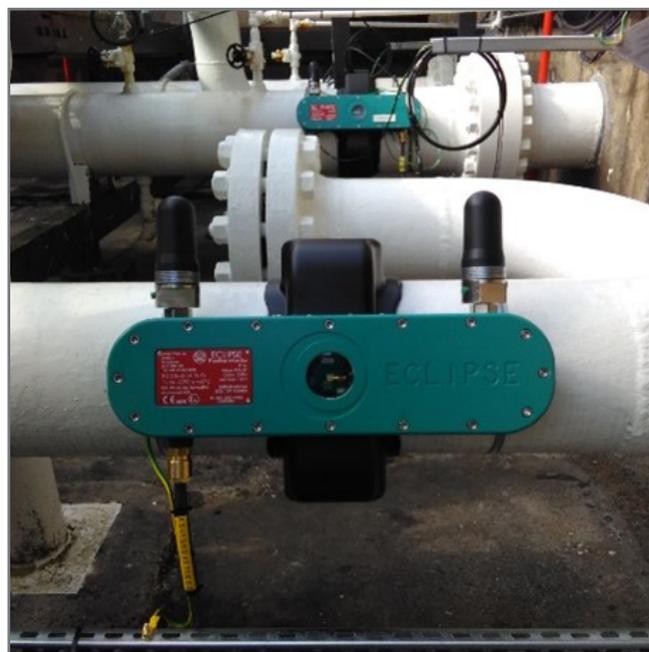
Figure 2: Atmos Eclipse installed

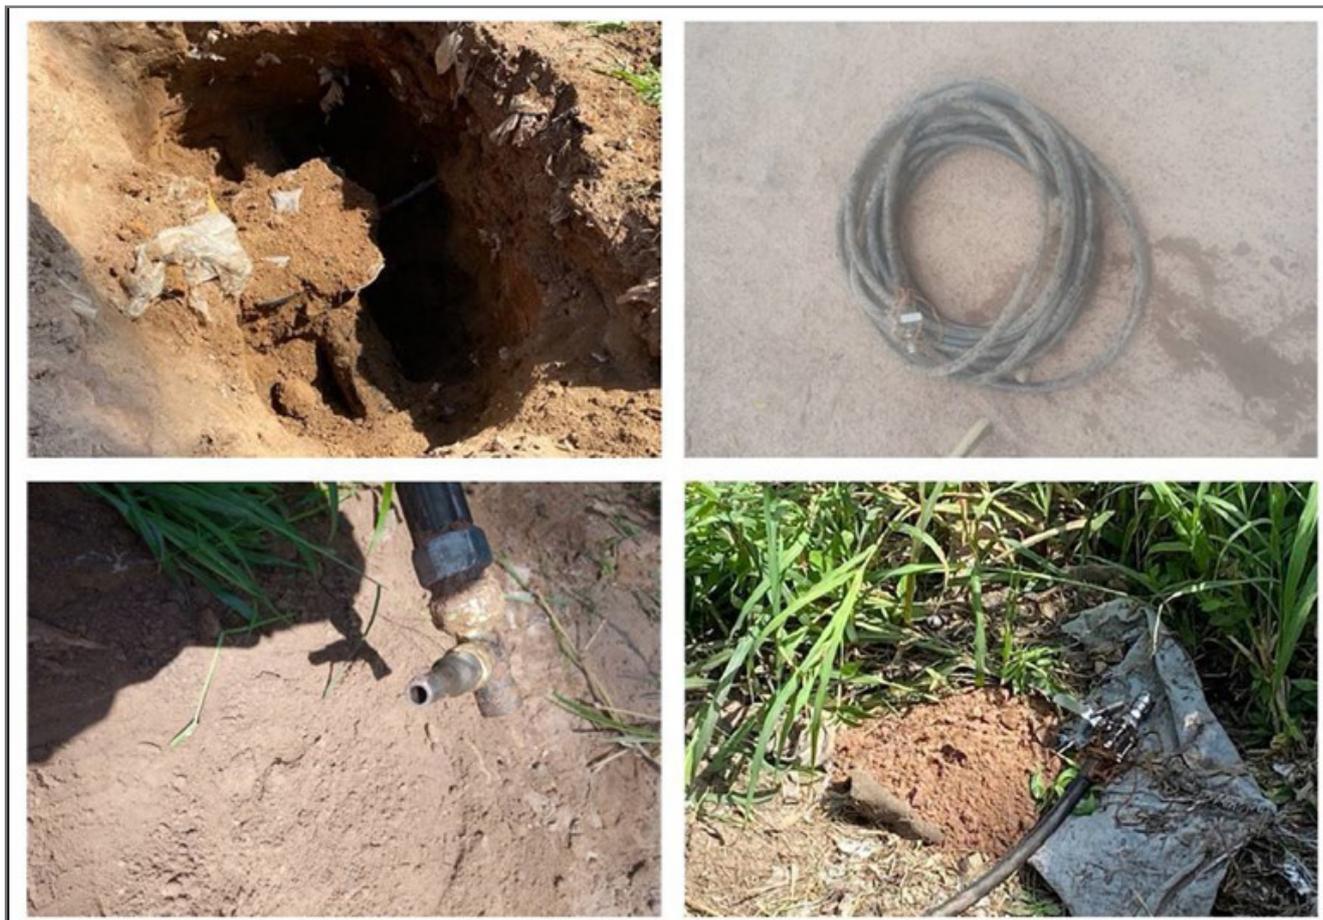
Figure 5: Selection of tapping points located by Atmos Odin in Congo

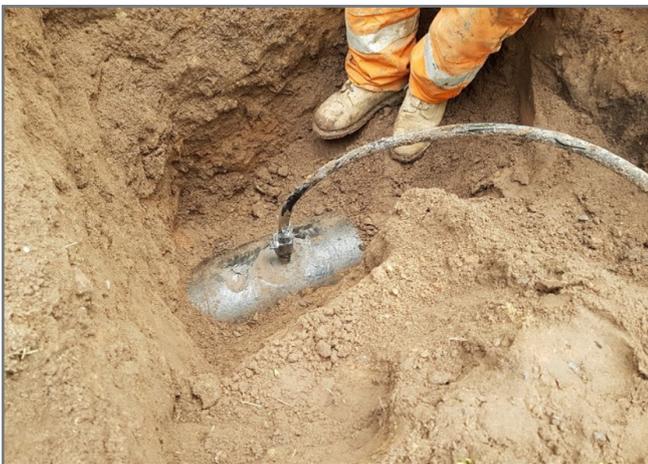
Figure 6: Tapping point exposed by the pipeline operator
